Annual Review

Stolthaven Bulk Fuel Storage Facility

Client: Stolthaven Australasia Pty Ltd

18-Dec-2014

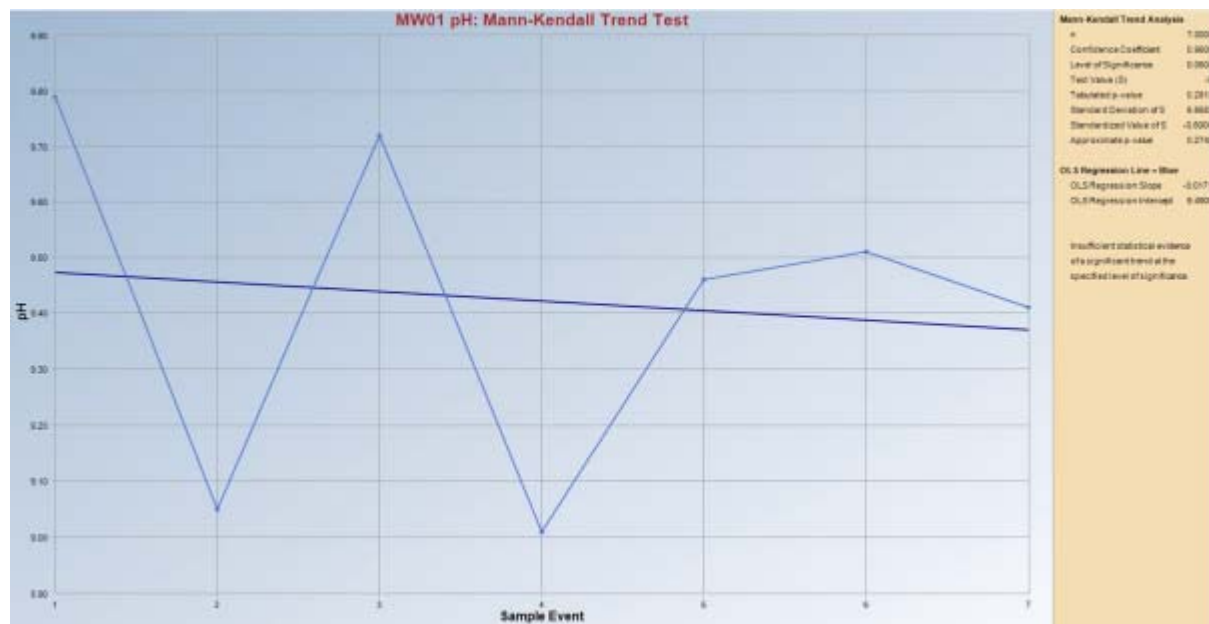
Figure 3 Statistical trend analysis for pH levels at MW01

pH levels recorded at MW01 for this reporting period ranged from 9.01 to 9.79, remaining within background levels recorded at the site. There was insufficient statistical evidence to confirm a significant trend in the data which is presented in **Figure 3**. At this preliminary stage it does not appear that site operations have a significant impact on pH levels at MW01.

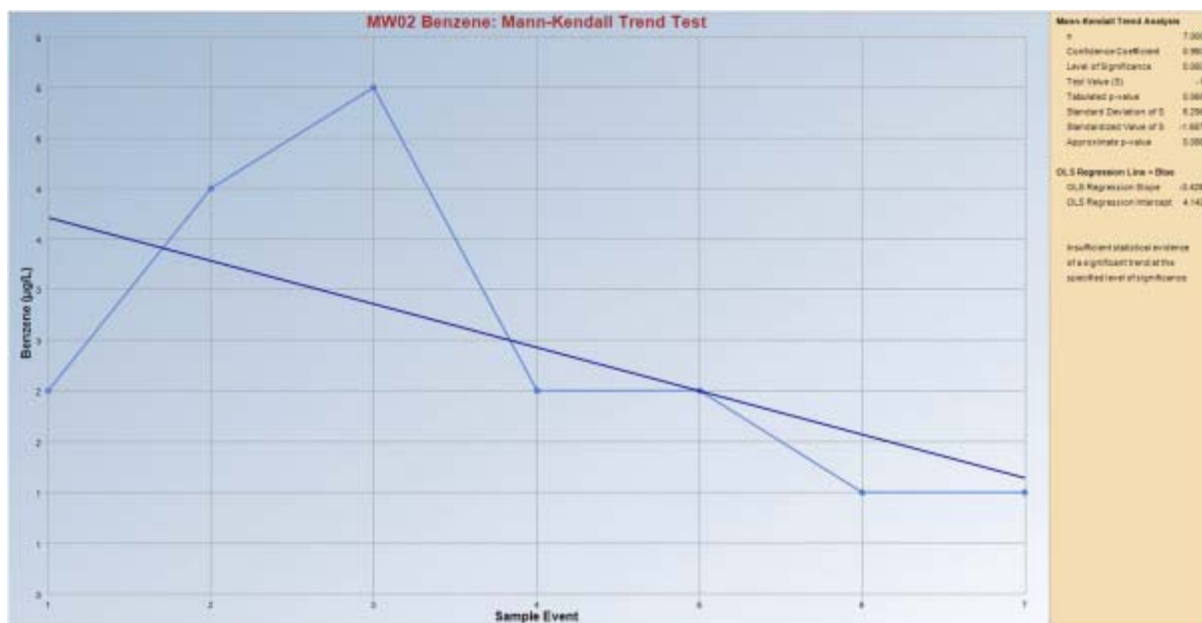
Figure 5 Statistical trend analysis for benzene concentrations at MW02

A value of 1µg/L of Benzene was recorded at MW02 during the August and November sampling events while a value of 2µg/L was recorded during the February and May events. These results were slightly below or equal to the lower range of 2 to 5µg/L recorded during background monitoring. Although Benzene has been recorded consistently at above LOR concentrations at MW02, statistical analysis indicates there is insufficient evidence to identify a statistically significant trend at the 95% confidence level. Data is presented as **Figure 5** below.

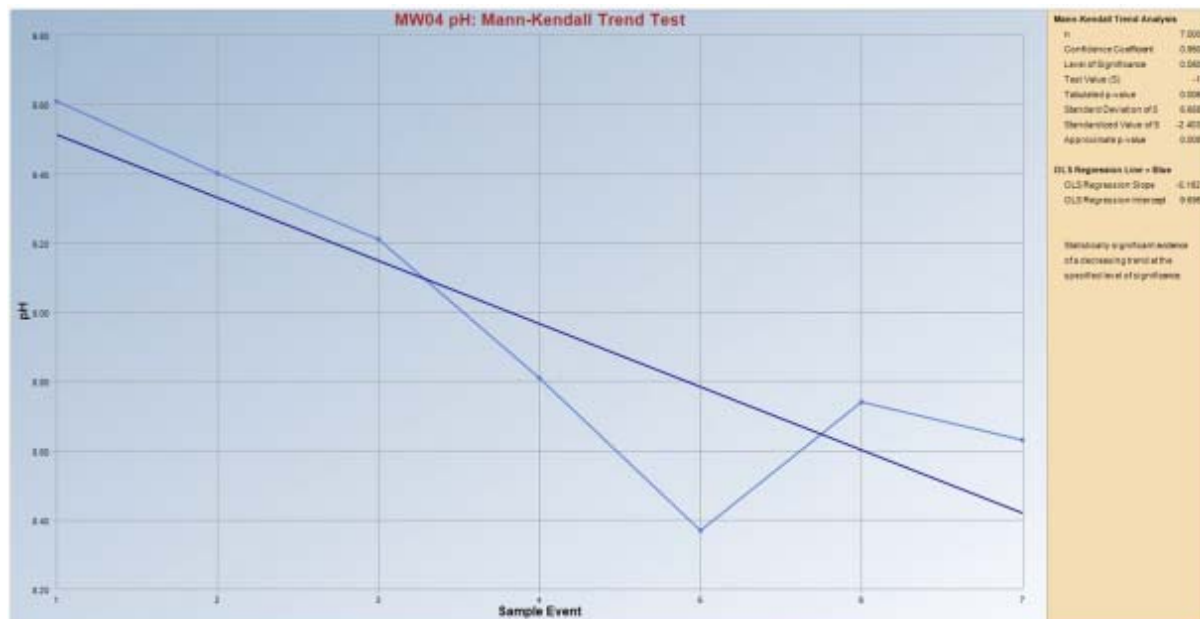
Figure 7 Statistical trend analysis for pH levels at MW04

pH levels recorded at MW04 for this reporting period ranged 8.37 to 8.81, with values below background levels recorded at the site. pH at MW04 has decreased overall, showing a downward trend since monitoring began in October 2013. Trend analysis conducted on this data indicates statistical evidence of a downward trend in pH at this location as presented in **Figure 7**. However due to the small sample size used in calculations, the trend is not considered significant at this stage.

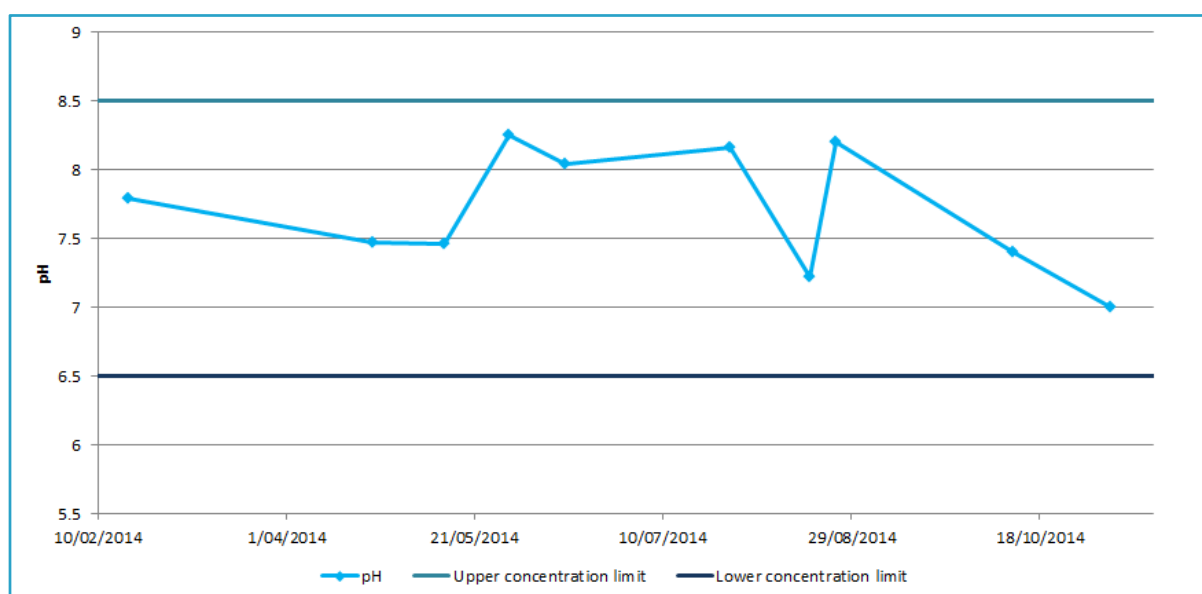
Figure 10 pH levels for discharged water at the Site

The recorded pH levels for discharged water at the site were compliant with the Site's EPL, remaining in the prescribed pH range of 6.5 – 8.5 as shown in **Figure 10** pH was recorded at an average of 7.7 with a maximum recording of 8.25 and a minimum recording of 7. While the sample size remains small, available data suggests that pH at the site remains stable within a range of 7 to 8.25.

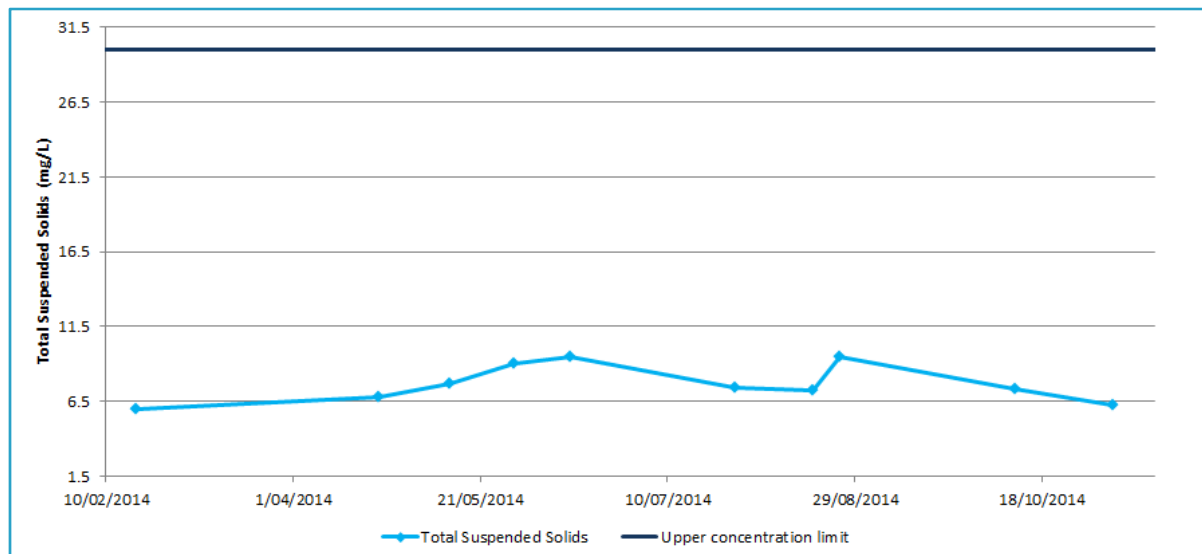
Figure 11 Total Suspended Solids Levels for discharged water at the Site.

The recorded Total Suspended Solids (TSS) levels for discharged water at the site were compliant with the Site's EPL, remaining significantly below the prescribed maximum concentration limit of 30 mg/L as shown in **Figure 11**. TSS levels were recorded at an average 19 mg/L, with a maximum recording of 29 mg/L which remained below the EPL concentration limit for the Site. While the sample size remains small, available data suggests TSS levels at the site remain stable within the range of 5 – 30 mg/L.

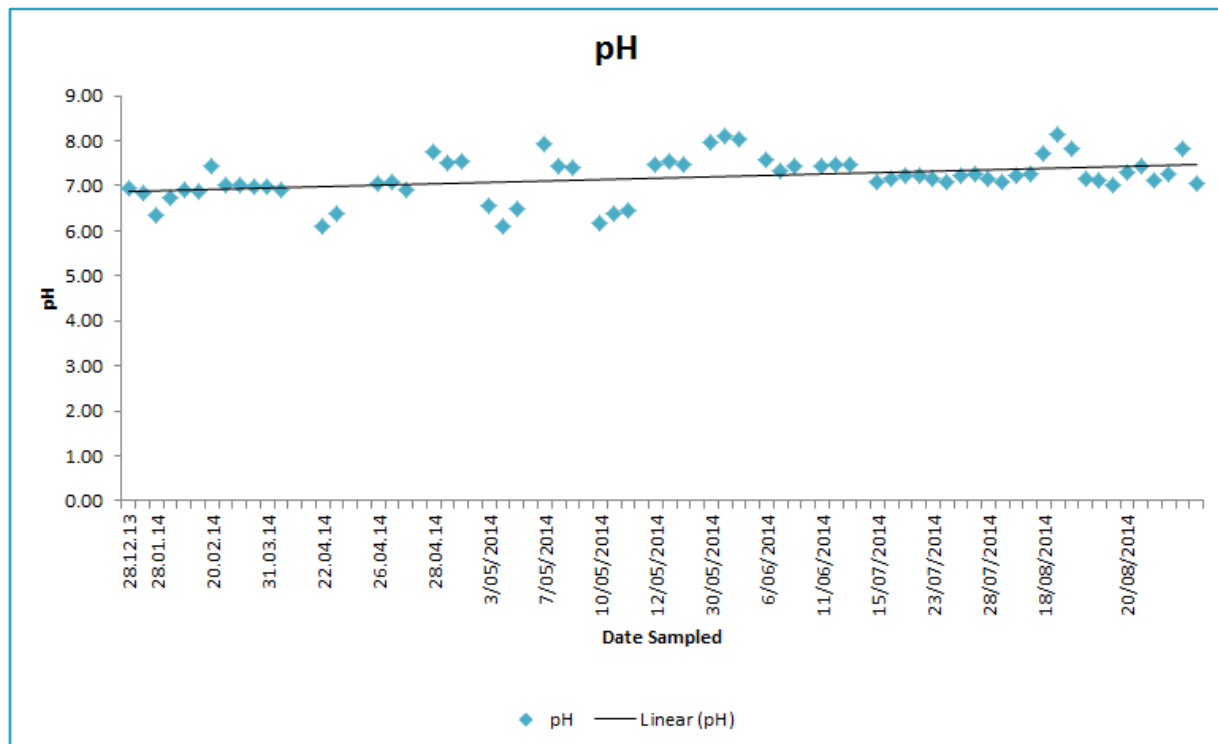
Figure 12 pH levels for Bund Water at the Site

pH levels at the site ranged from 6.10 to 8.15 and were recorded at an average of 7.25. pH levels in the bunds were recorded as being below the minimum concentration limit given for the Site's licenced discharge point on seven occasions but as discussed above, these pH levels were identified in water quality analysis of the bunds and the water was then treated until the pH was above the minimum concentration limit before it was discharged. As shown in **Figure 12** there is a very slight increasing linear trend in pH although this is not of concern to Stolthaven considering the magnitude of the trend and the treatment measures in place to control the pH of water discharged from the Site.

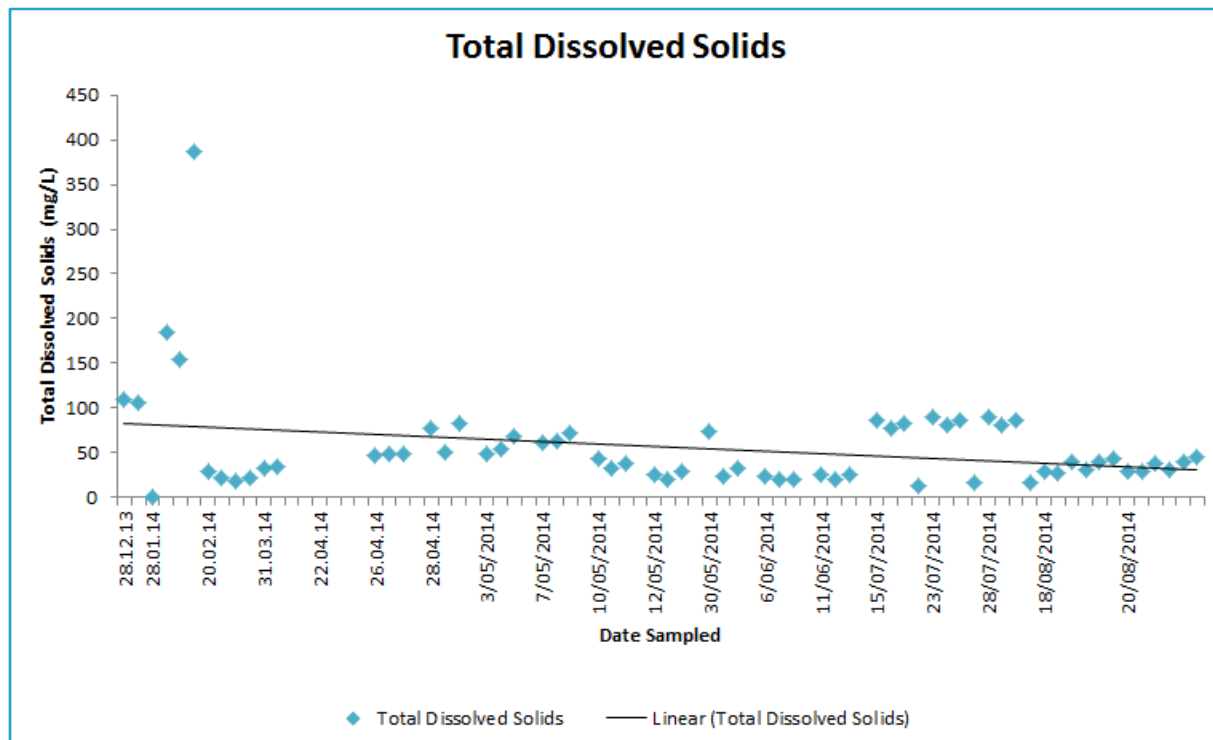
Figure 13 Total Dissolved Solids Concentrations for Bund Water at the Site.

TDS levels at the site ranged from 0.10 to 387ppm and were recorded at an average of 56ppm. The very high TSS readings of 185, 154 and 387ppm from samples taken on the 28/01/2014 were not analysed until 3 months after sampling had taken place and are therefore not an accurate representation of water quality. As shown in **Figure 13**, TDS levels in the bund water at the site were fairly stable between 0-100ppm omitting the unreliable concentrations from early in the reporting period. There is a slight decreasing linear trend in TDS concentrations over the reporting period which indicates increasing water quality and the effectiveness of surface water management measures on site.

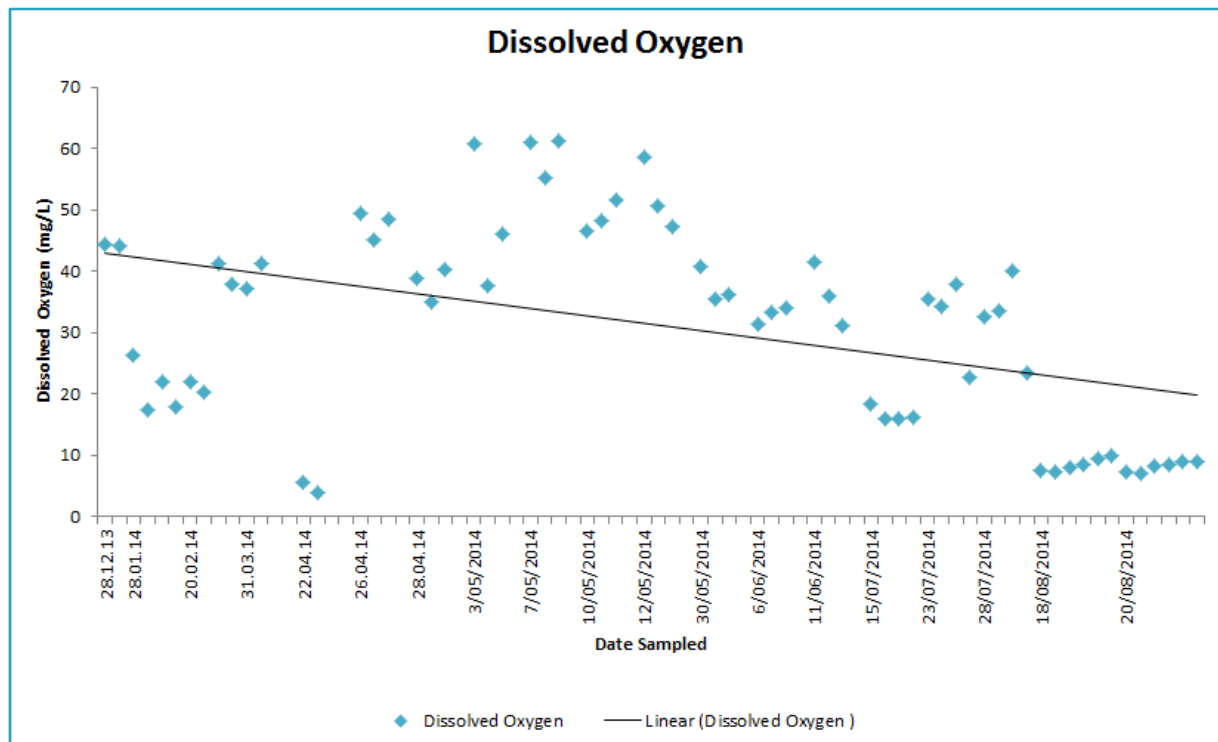
Figure 14 Dissolved Oxygen Concentrations for Bund Water at the Site

Dissolved oxygen concentrations at the site ranged from 4 to 62 mg/L and were recorded at an average of 28 mg/L. pH levels in the bunds were recorded as being above the minimum concentration limit given for the Site's licenced discharged point for all sampling events. As shown **Figure 14**, dissolved oxygen concentrations were quite varied over the reporting period and a decreasing linear trend in concentration was identified. This trend should be considered in light of the small data sample size and monitored in future reporting periods. As discussed above, even if low dissolved oxygen concentrations levels are identified in the bund water, this water is treated before it is discharged from the Site.
