Annual Review

Stolthaven Bulk Fuel Storage Facility

07-Mar-2016

Document Annual Review

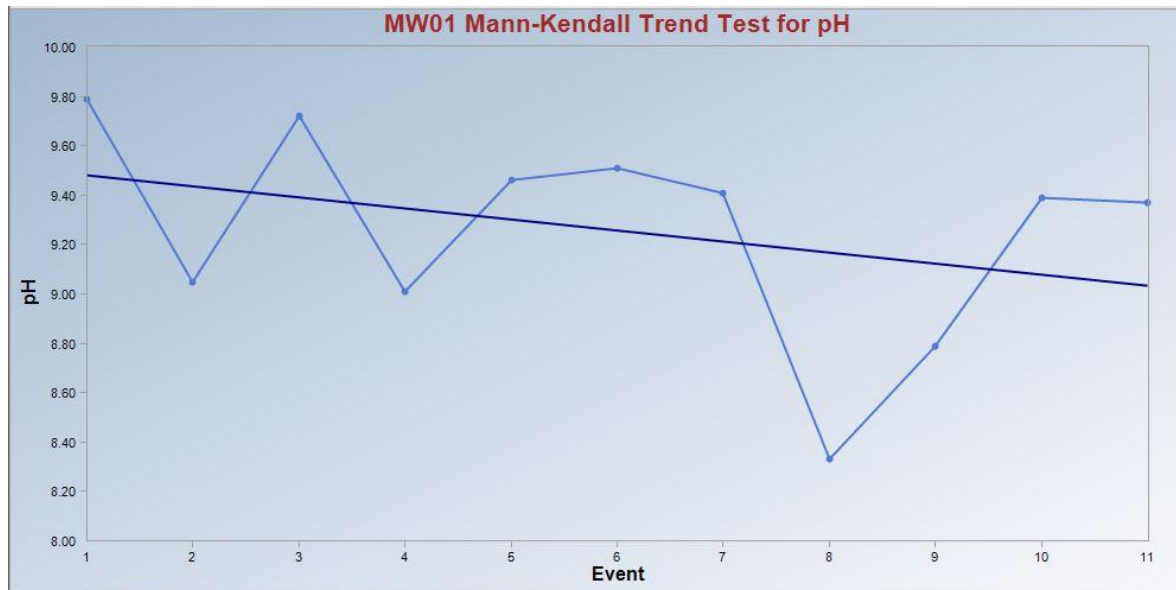
Total Recoverable Hydrocarbons (TRH) concentrations were below Laboratory Limits of Reporting (LOR) at MW01 and were consistent with background levels established for the Site.

BTEX concentrations were also below the LOR at this monitoring point and it appears that BTEX concentrations are stable below the LOR at MW01.

Figure 4 Statistical trend analysis for pH levels at MW01

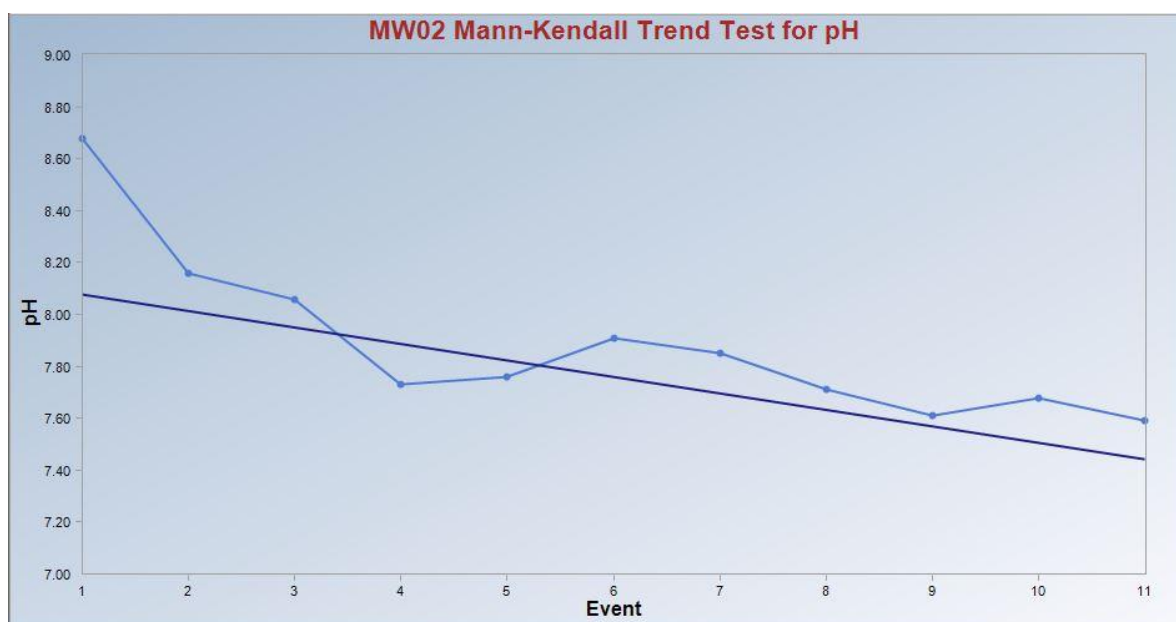
TRH concentrations were below the LOR at MW02 and were consistent with background levels established for the Site. TRH fractions have generally not been recorded at MW02 since monitoring at the Site began, apart from one recorded low concentration in the >C16-C34 fraction (380 µg/L) in October 2013. Overall, TRH concentrations appear to be stable at below LOR concentrations.

Figure 5 Statistical trend analysis for pH levels at MW02

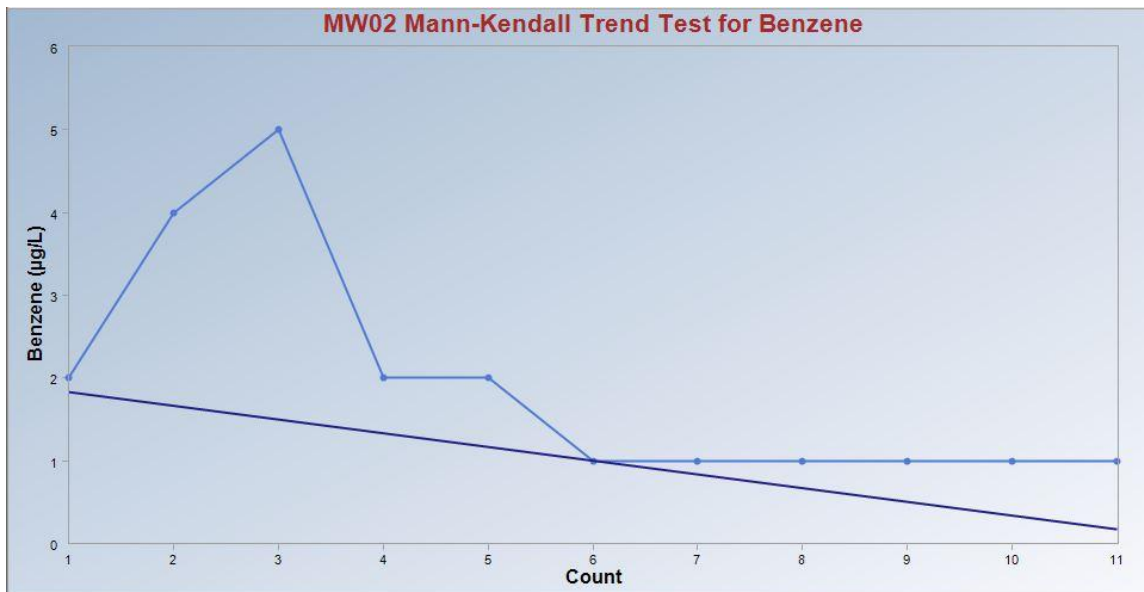
BTEX concentrations were also below the LOR at this monitoring point and it appears that generally BTEX concentrations are stable below the LOR at MW03. Higher concentrations of benzene have previously been recorded at MW02, however trend analysis showed statistically significant evidence of a decreasing trend in benzene concentration at MW02 (refer **Figure 6**). Benzene concentrations appear to have stabilised at below LOR concentrations over the last 6 monitoring events.

Figure 6 Statistical trend analysis for Benzene levels at MW02

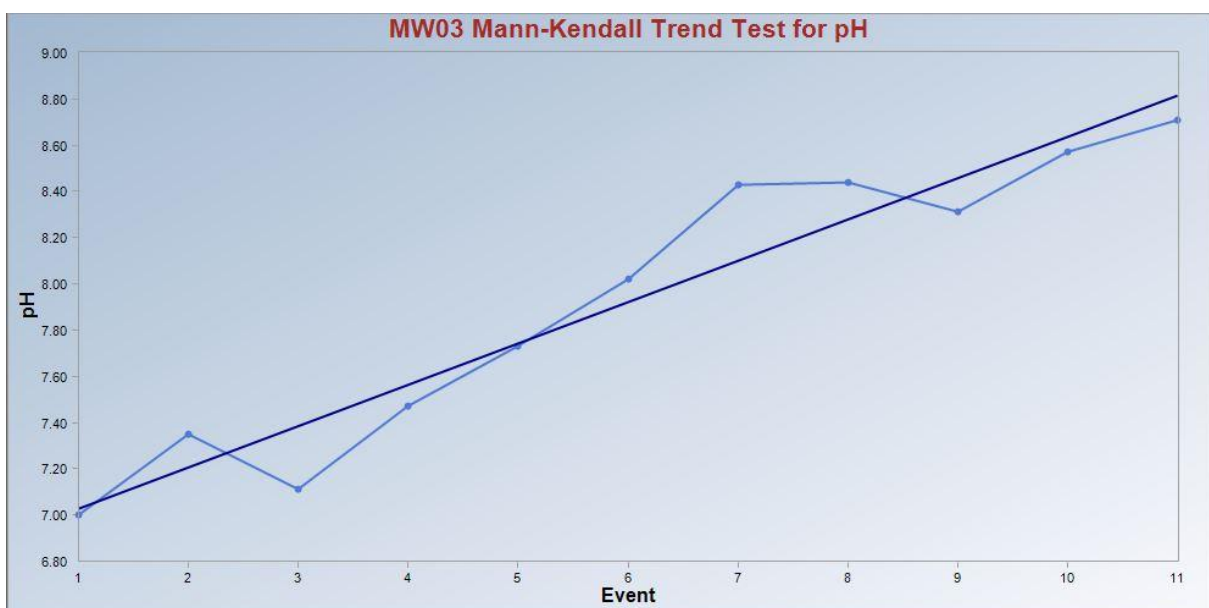
TRH concentrations were below the LOR at MW03 and were consistent with background levels established for the Site. TRH fractions have generally not been recorded at MW03 since monitoring at the Site began, apart from one recorded low concentration in the >C16-C34 fraction (180 µg/L) in October 2013. Overall, TRH concentrations appear to be stable at below LOR concentrations.

BTEX concentrations were also below the LOR at this monitoring point and it appears that BTEX concentrations are stable below the LOR at MW03.

Figure 7 Statistical trend analysis for pH levels at MW03

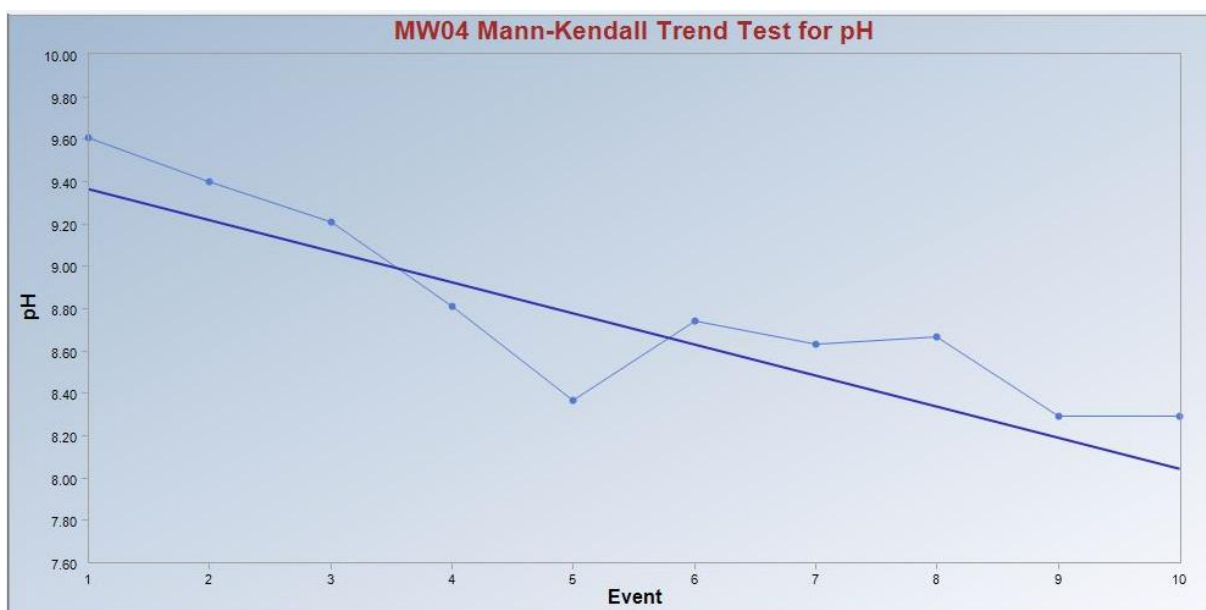
TRH concentrations were below the LOR at MW04 and were consistent with background levels established for the Site.

BTEX concentrations were also below the LOR at this monitoring point and it appears that BTEX concentrations are stable below the LOR at MW04.

Figure 8 Statistical trend analysis for pH levels at MW04

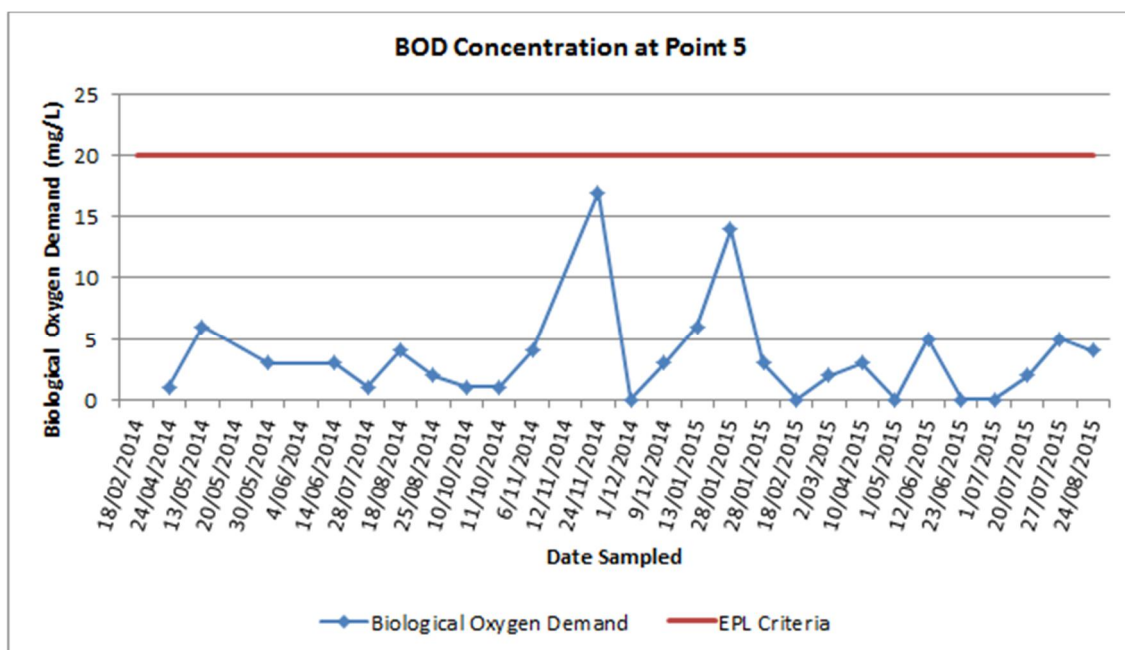
The BOD concentrations recorded at Monitoring Point 5 complied with the Site's EPL criteria, remaining below the prescribed maximum concentration limit of 20 mg/L. The results for the reporting period are shown in **Figure 9** along with the historical BOD concentrations recorded at Monitoring Point 5. The average BOD concentration during the reporting period was 5.7 mg/L, with a maximum recorded concentration of 17 mg/L. With the exception of two monitoring events, BOD concentrations have remained within the range of 1 – 6 mg/L. The criterion for BOD was removed from EPL 20193 on 27 August 2015 and so results are only presented for monitoring events prior to that date.

Figure 9 BOD levels at Monitoring Point 5

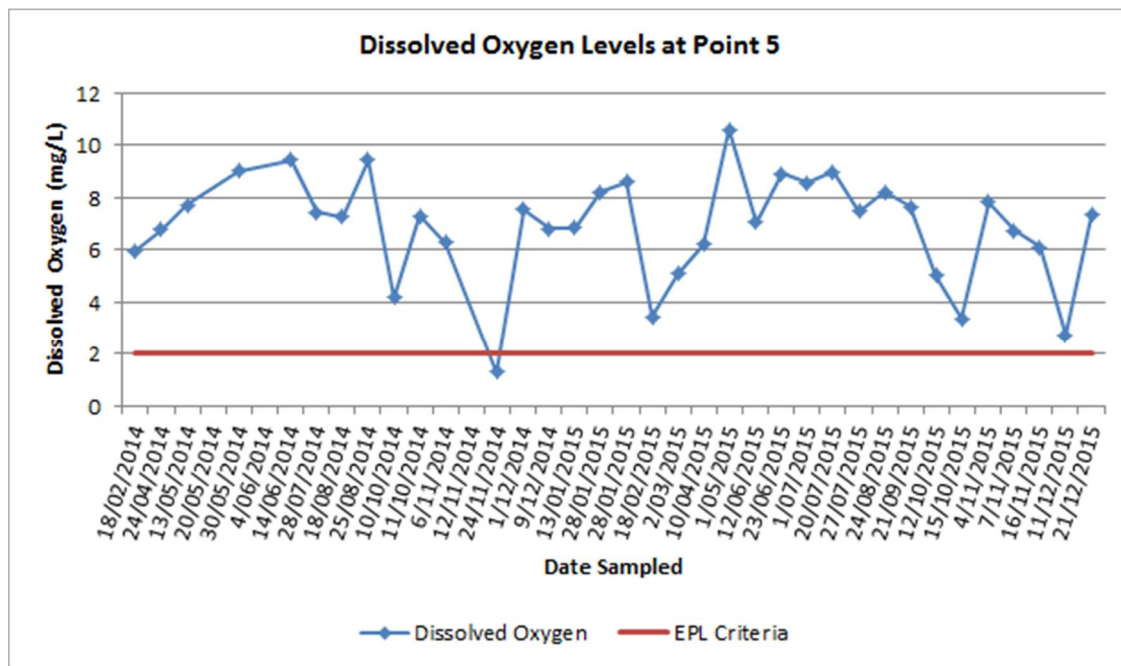
The dissolved oxygen levels recorded at Monitoring Point 5 generally complied with the Site's EPL criteria, with results generally above the prescribed minimum concentration limit of 2 mg/L. There was one exceedance of the criteria on 24/11/2014 (1.3 mg/L); however the water was treated and retested and subsequently found to comply with the criterion. The results for the reporting period are shown in **Figure 10** along with the historical results for dissolved oxygen levels recorded at Monitoring Point 5. The average dissolved oxygen level recorded during the reporting year was 6.6 mg/L, with a minimum level of 1.3 mg/L. The historical results indicate that dissolved oxygen at Monitoring Point 5 is variable, with no apparent trend identified.

Figure 10 Dissolved Oxygen levels at Monitoring Point 5

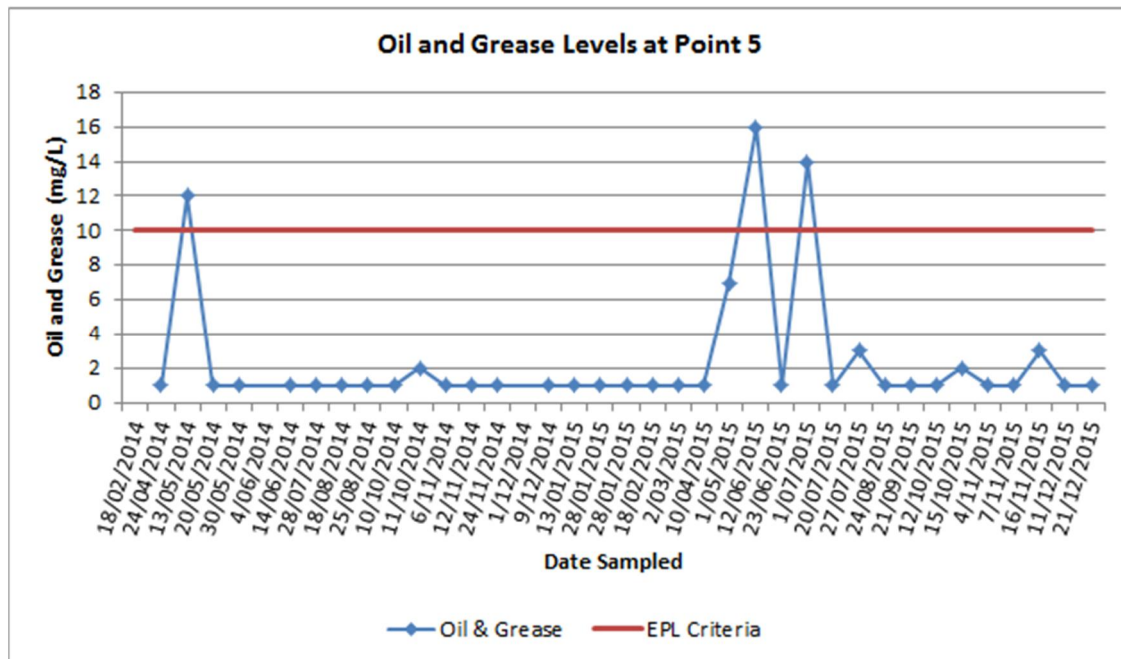
The oil and grease levels recorded at Monitoring Point 5 during the reporting period were generally compliant with the EPL concentration limit of 10 mg/L. There were two exceedances of the criterion on 12/06/2015 and 01/07/2015. On both occasions the affected water was pumped out and removed off site by a licensed contractor. The results for the reporting period are shown in **Figure 11** along with the historical results for oil and grease levels recorded at Monitoring Point 5. The average level of oil and grease recorded during the reporting period was 7.5 mg/L, with a maximum of 16 mg/L. The results shown in **Figure 11** indicate that oil and grease levels generally remain below 3 mg/L.

Figure 11 Oil and Grease levels at Monitoring Point 5

Note: Concentrations recorded as below the LOR for Oil and Grease (<2 mg/L) are represented as 1 mg/L

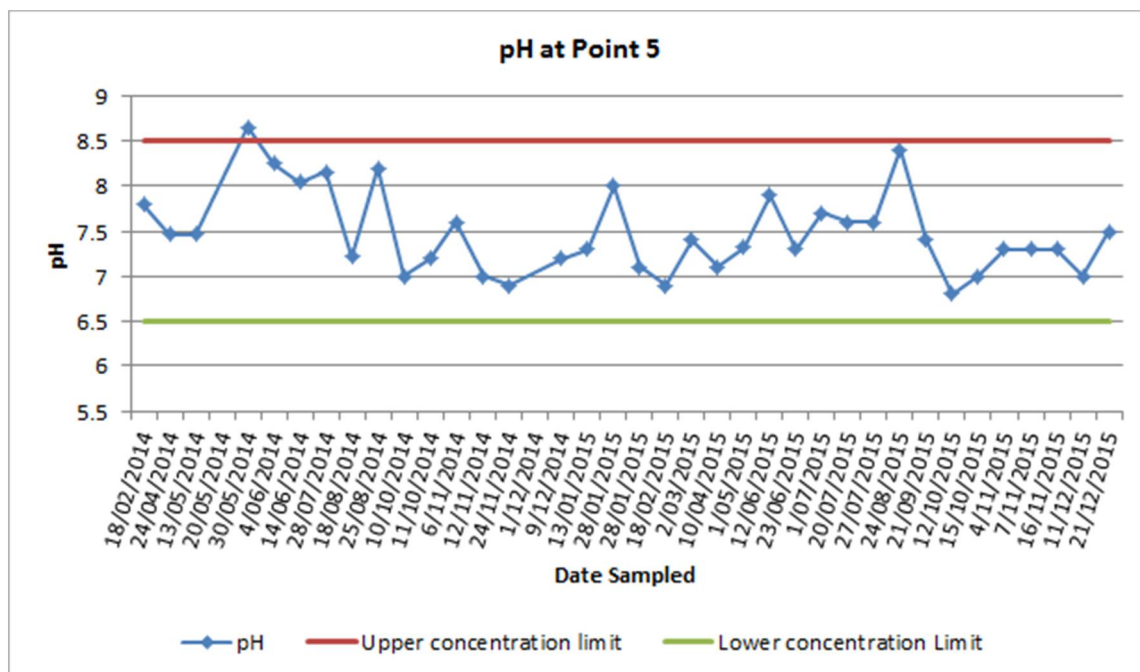
The pH levels recorded at Monitoring Point 5 complied with the Site's EPL criteria, remaining within the prescribed pH range of 6.5 – 8.5. The results for the reporting period are shown in **Figure 12** along with the historical results for pH levels recorded at Monitoring Point 5. During the reporting period, the average pH level recorded was 7.3, with a maximum recording of 8.4 and a minimum recording of 6.8. The historical results indicate that pH levels at Monitoring Point 5 generally remain within the range of 7 to 8.

Figure 12 pH levels at Monitoring Point 5

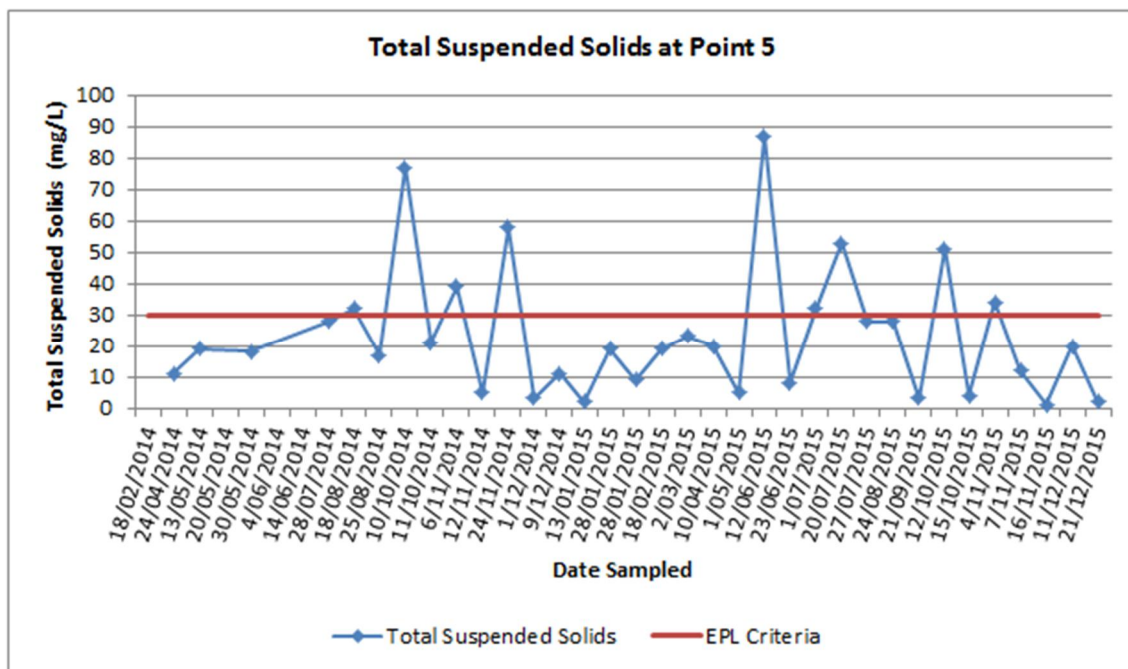
The total suspended solids levels recorded at Monitoring Point 5 varied throughout the reporting period, with several exceedances of the EPL limit of 30 mg/L. Exceedances occurred on 6/11/2014, 24/11/2014, 12/06/2014, 01/07/2015, 20/07/2015, 12/10/2015 and 04/11/2015. On five occasions the affected water was treated, retested and subsequently complied with the EPL limit. However on two occasions the affected water was pumped out and removed off site by a licensed contractor.

Results for the reporting period are shown in **Figure 13** along with the historical results for total suspended solids levels recorded at Monitoring Point 5. During the reporting period, the average level of total suspended solids was 23.7, with a maximum recording of 87.0 mg/L. The historical results indicate that the level of total suspended solids at Monitoring Point 5 is variable, with no apparent trend identified.

Figure 13 Total suspended solids levels at Monitoring Point 5

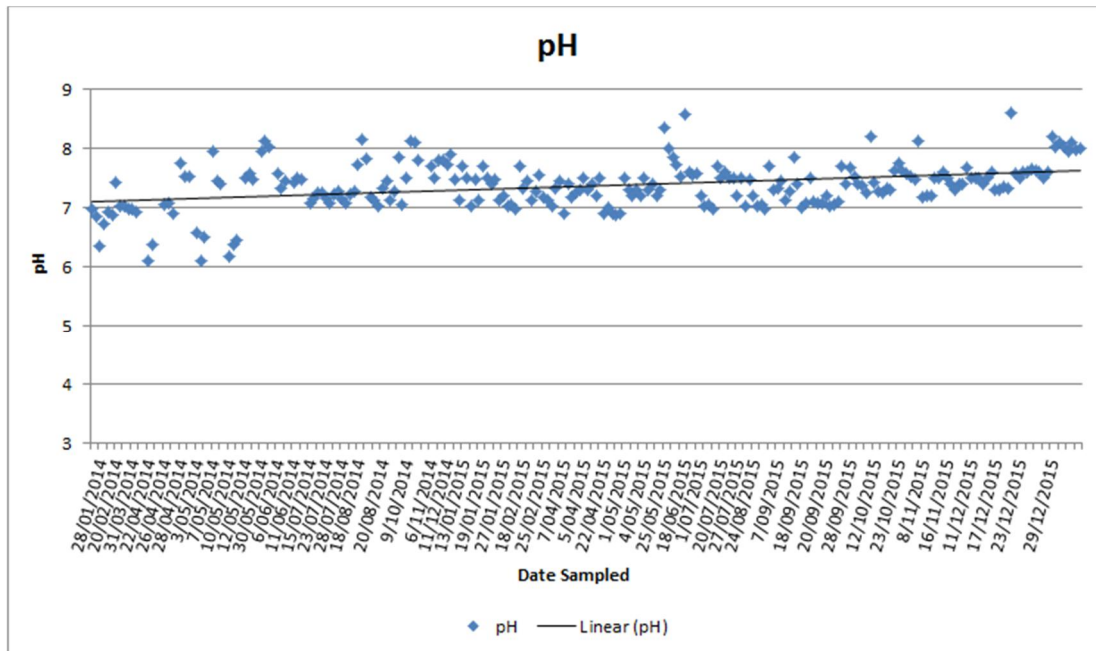
The pH levels recorded in the bund water during the reporting period ranged from 6.87 to 8.58, with an average pH of 7.4. Results for the reporting period are shown in **Figure 14** along with historical results. The pH levels during the reporting period were generally within the pH range of 6.5 – 8.5 prescribed in EPL criteria for the licensed discharge point (Monitoring Point 5). On two occasions, pH was recorded as being above the maximum pH limit of 8.5 (pH of 8.56 on 18 June 2015 and 8.58 on 17 December 2015). There is a very slight increasing linear trend in pH although this is not presently of concern considering the magnitude of the trend and the

treatment measures in place to control the pH of water discharged from the Site. Nonetheless, this trend should be closely monitored during future monitoring events.

Figure 14 pH levels recorded in bund water at the Site

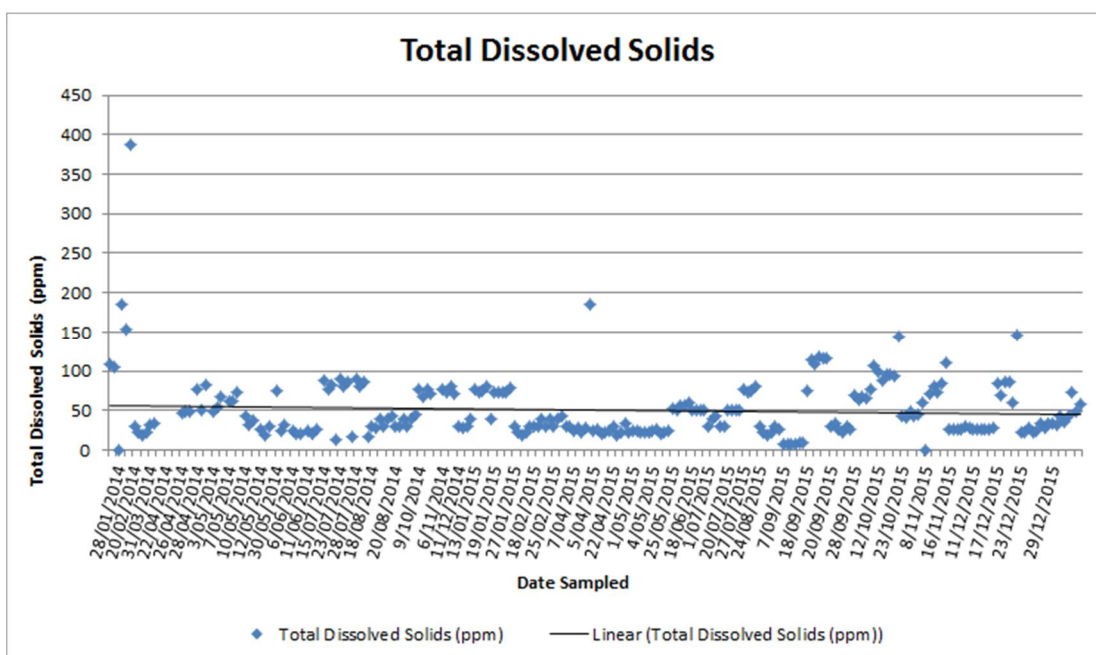
TDS levels in bund water during the reporting period ranged from 0 to 185 ppm, with an average of 47.8 ppm. Results for the reporting period are shown in **Figure 15** along with historical results. TDS levels in the bund water during the reporting period were quite variable. Historically TDS levels at the Site have been relatively stable between 0 -100 ppm, with the exception of occasional samples with higher levels. During the current reporting period ten samples recorded levels higher than 100 ppm. No discernible trend was identified in TDS levels recorded in bund water at the Site.

Figure 15 Total Dissolved Solids concentrations recorded in bund water at the Site

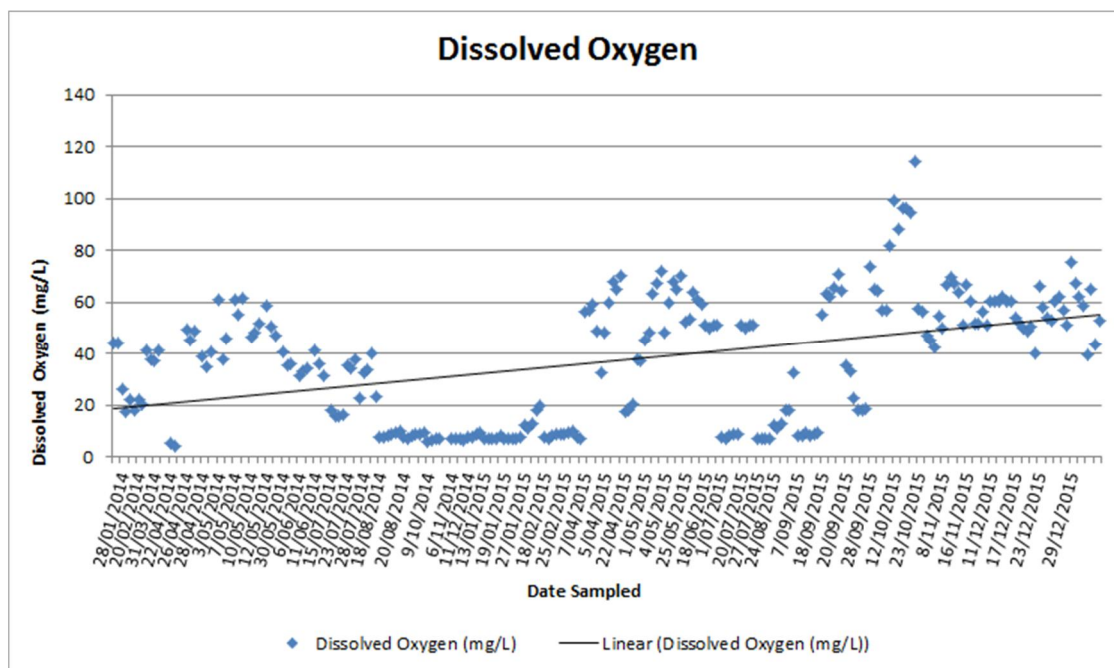
Dissolved oxygen concentrations in bund water during the reporting period ranged from 6.4 to 114 mg/L, with an average concentration of 40.9 mg/L. Results for the reporting period are shown in **Figure 16** along with historical results. While dissolved oxygen concentrations were varied throughout the reporting period, an increasing linear trend was identified which can indicate increasing water quality.

Figure 16 Dissolved oxygen levels in bund water at the Site

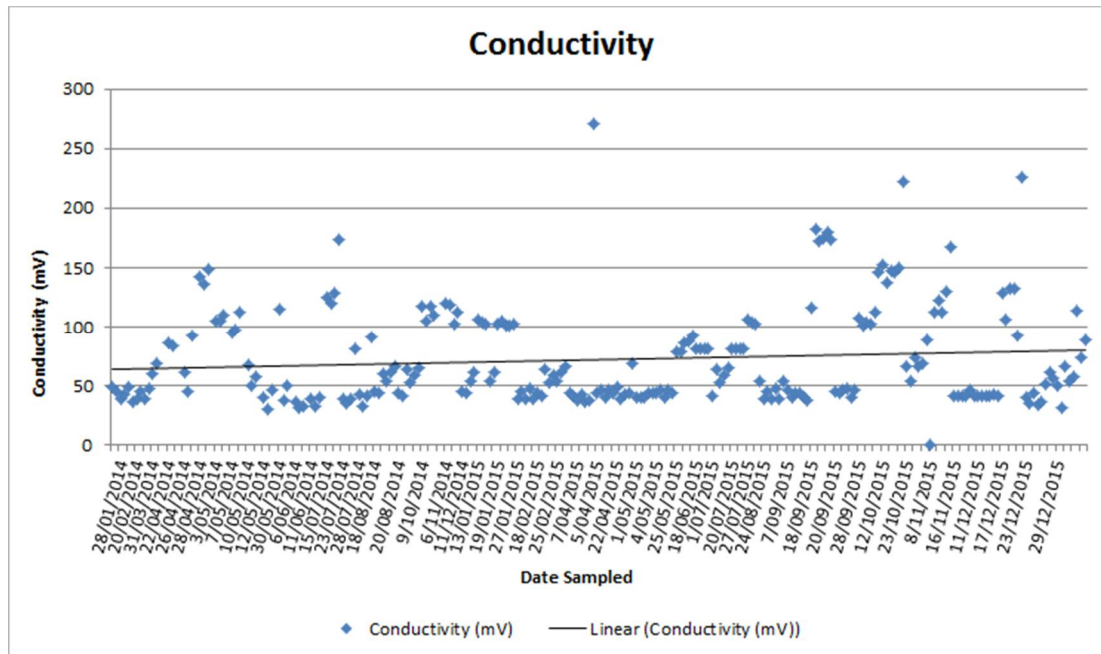
Conductivity levels in bund water during the reporting period ranged from 0.1 to 271 $\mu\text{S}/\text{cm}$, with an average conductivity of 74.4 $\mu\text{S}/\text{cm}$. Results for the reporting period are shown in **Figure 17** along with historical results. While conductivity levels varied during the reporting period, an increasing trend was identified in the historical results. This may indicate an increase in dissolved salts and other inorganic chemicals. This trend is not of great concern at present, given the small data sample size (two years) and the treatment measures in place to control the water quality parameters for water discharged from the Site. Nonetheless, this trend should be closely monitored during future monitoring events.

Figure 17 Conductivity levels in bund water at the Site

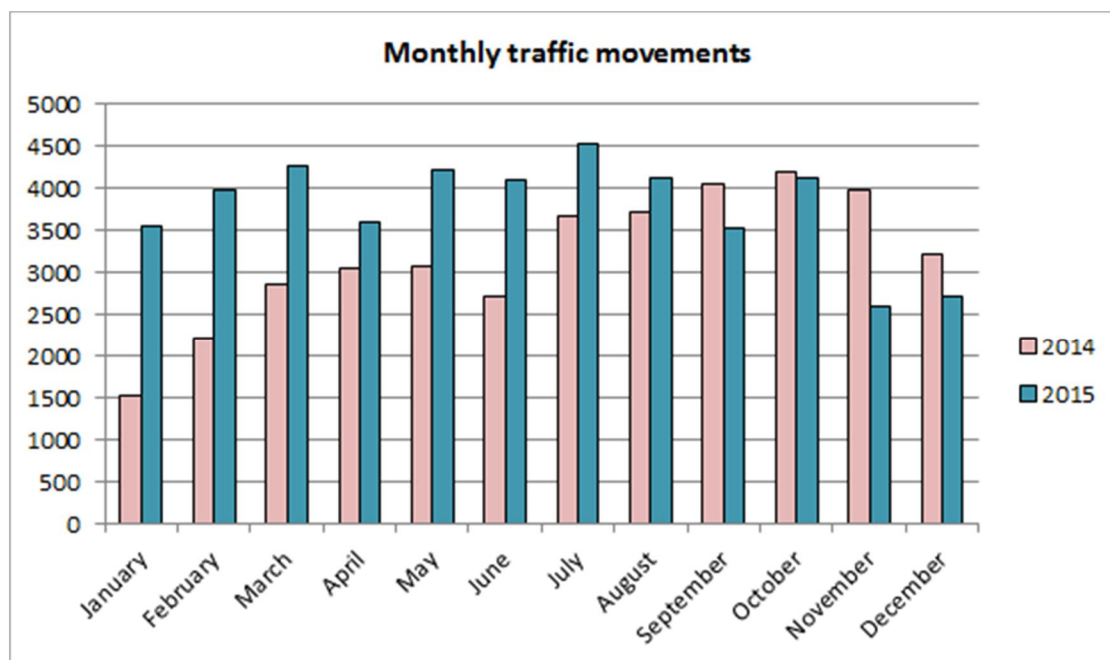
During the busiest month of operations throughout the review period (July 2015), movements from Stolthaven averaged up to 145 movements per day which is the equivalent of approximately 6 per hour. This is well within the Concept Plan's initial limits listed above.

The only other major operation within the Concept Plan area is Mayfield Berth 4. While exact truck movements for M4 are not available it is considered highly unlikely that M4 traffic generation would be greater than Stolthaven and therefore total truck numbers would be within the Concept Plan limits.

Figure 18 Comparison of monthly truck movements
