# Stolthaven Annual Review 2021

Stolthaven Australia Pty Ltd

14 April 2022

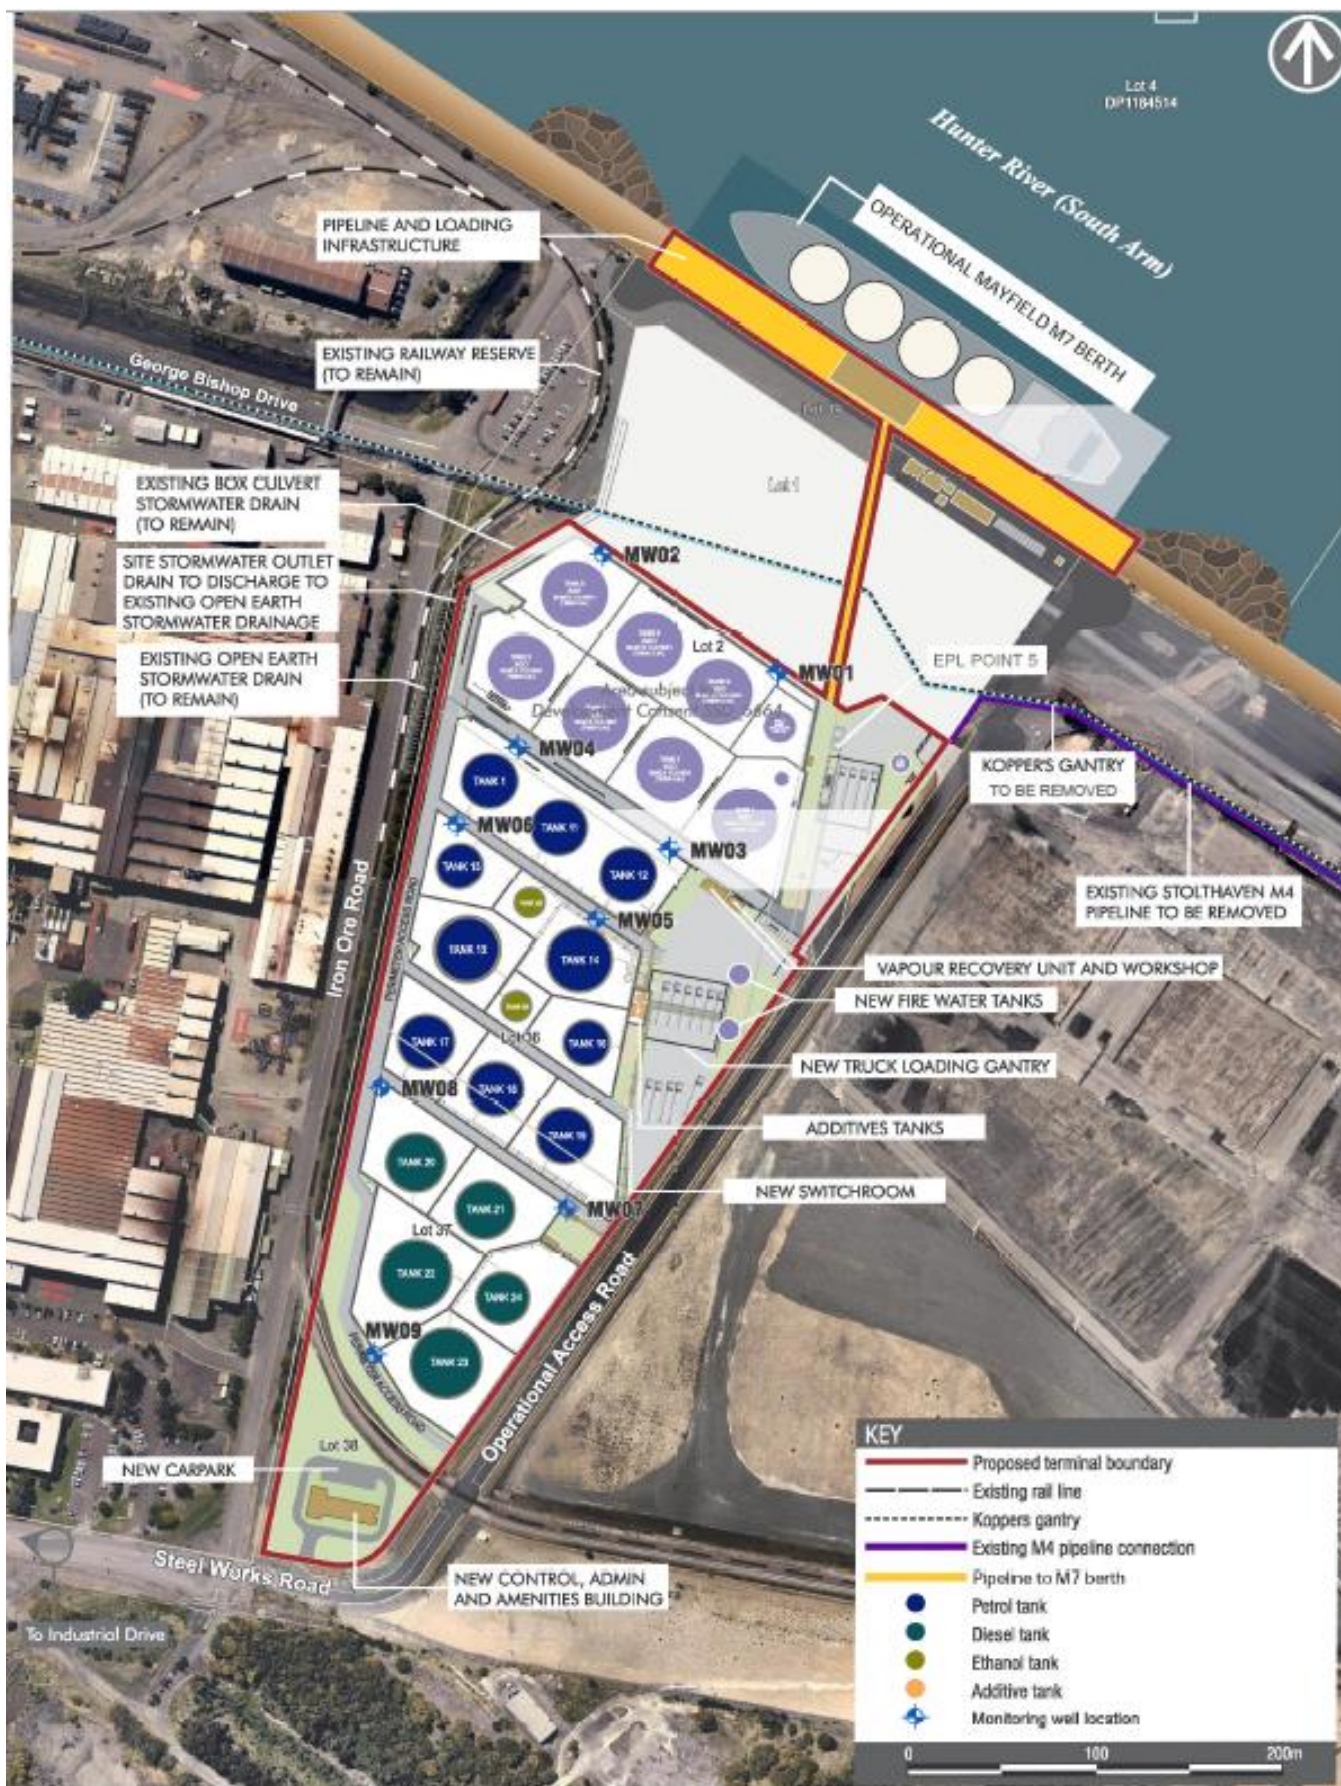
Figure 4.1 Groundwater monitoring well locations

Groundwater monitoring well locations are shown on Figure 4.1.

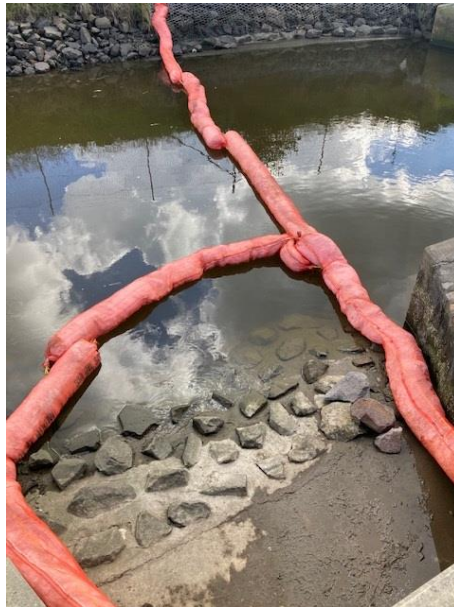
*Floating booms deployed at Western drain outlet*

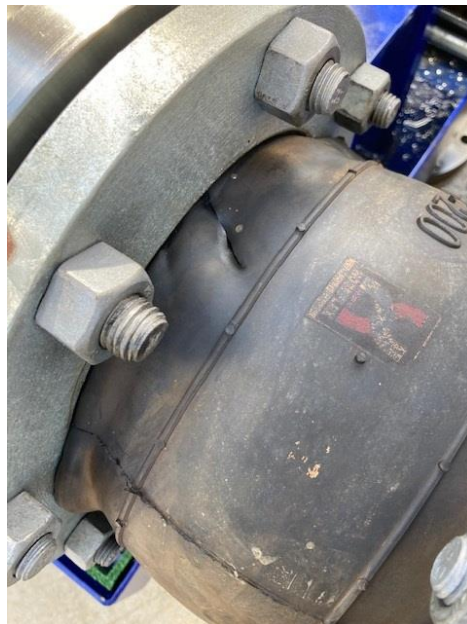
On 18 April 2021, a diesel spill from a filtration skid occurred owing to the failure of a Nitrile bellow connecting two filtration skids. Approximately 700-800 litres of diesel was released into a bunded area with splash entering into the site's stormwater drain system. The site's Emergency Response Plan, action card 2 – Loss of Contamination & Pollution Incident Response Management Plan was activated, stopping the operation and spill equipment was deployed. The spilled volume was contained on the premises and recovered. As the incident had the potential to harm the environment, 7 agencies were notified of the incident.

*Bellow external*

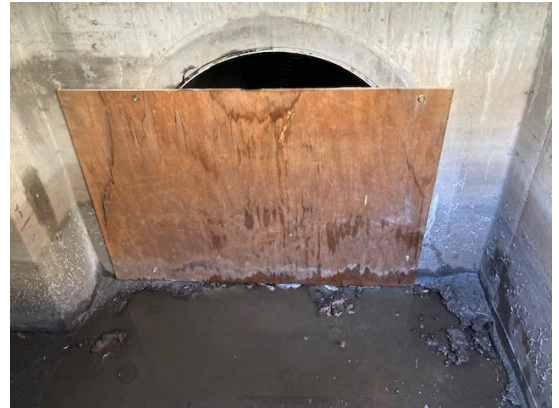
*Sealing of Stormwater drain (Plywood/Sika seal)  
fuel absorbent material placed on inner side.*

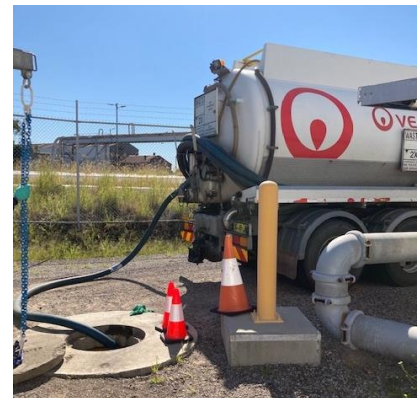
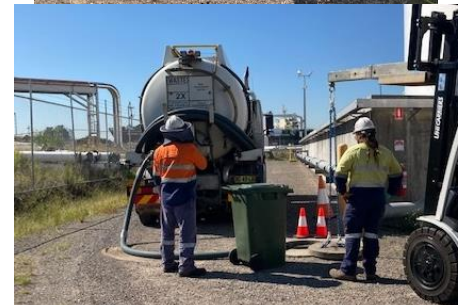
*Clean up process following incident*

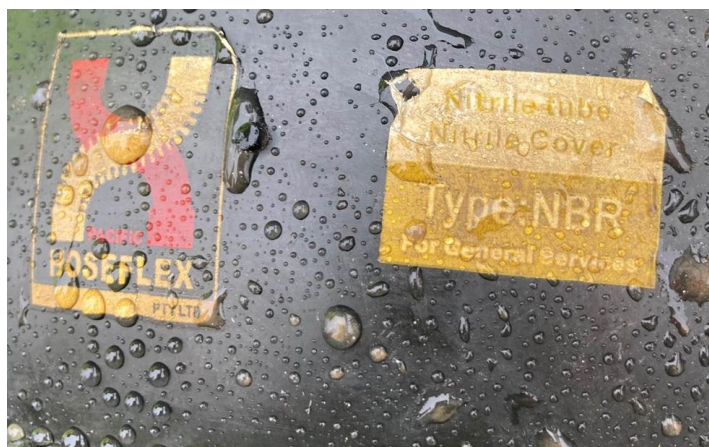
*Photo: Bellow prior to install (rainwater)*

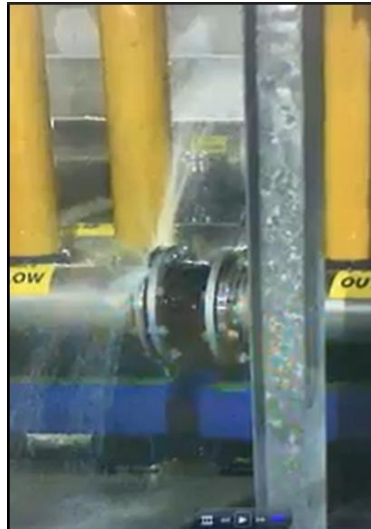
**Physical (cont'd)**      *Photo: Screen capture of CCTV footage during spill*

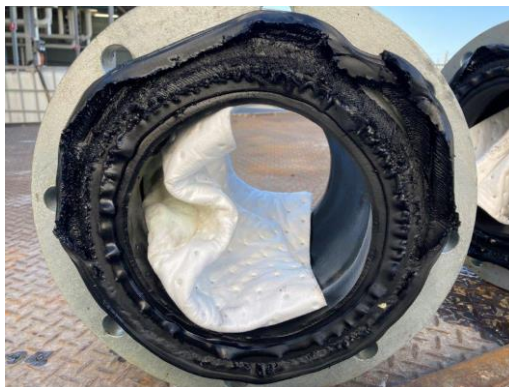
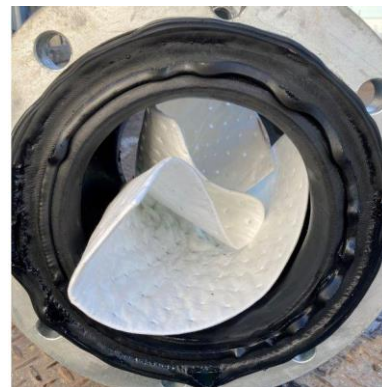
*Outlet flange*

Following the incident, the bellows were removed from service and inspected on April 19<sup>th</sup> 2021.

Internal inspection indicates a chemical reaction and breakdown of the rubber material on both bellows in service.
