Annual Review

Stolthaven Bulk Fuel Storage Facility

Client: Stolthaven Australasia Pty Ltd

18-Dec-2014

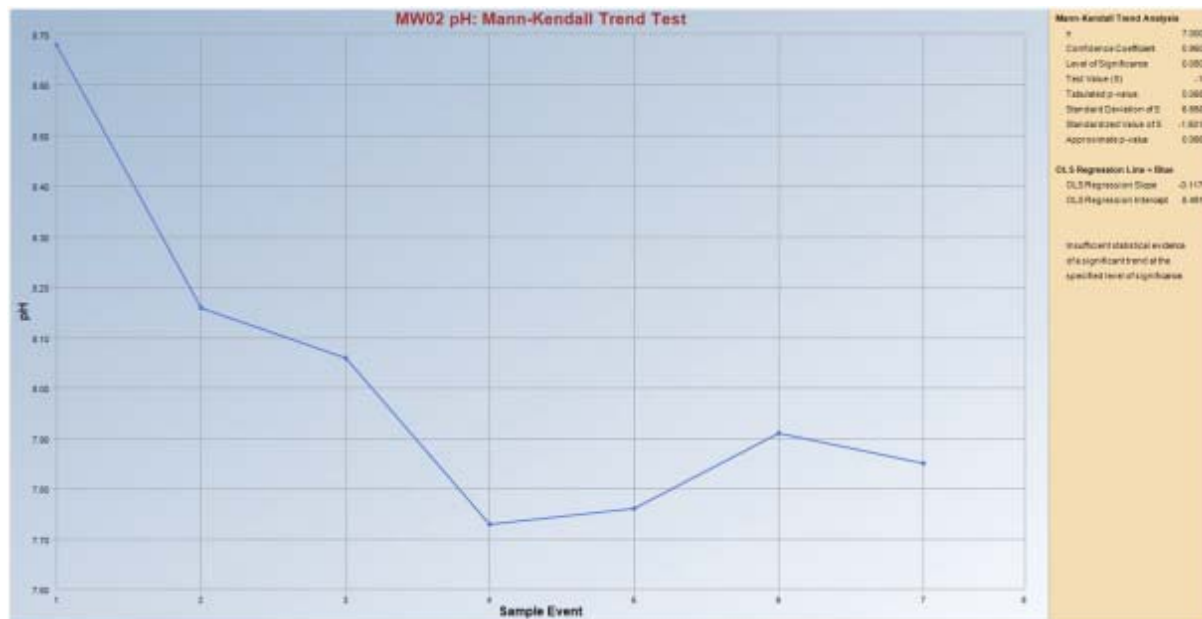
Figure 4 Statistical trend analysis for pH levels at MW02

pH levels recorded at MW02 for this reporting period ranged from 7.73 to 7.91 and were below background levels recorded at the site. While **Figure 4** below shows a general decrease in pH over time, there was insufficient statistical evidence to confirm this as a significant trend in the data at this stage.

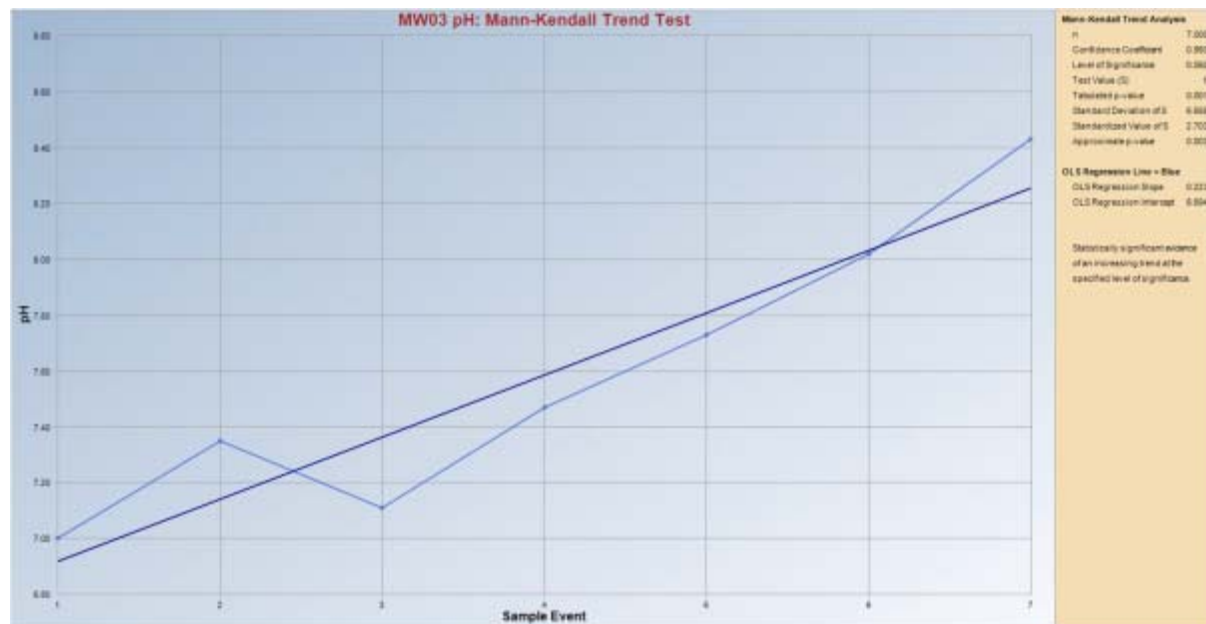
Figure 6 Statistical trend analysis for pH levels at MW03

pH levels recorded at MW03 for this reporting period ranged from 7.47 to 8.43, with values above background levels recorded at the site. pH values at this location have increased steadily since records began. As shown in **Figure 6** there is evidence of a trend in the data. However given the small sample size used in calculations, the trend is not considered to be statistically significant at this stage.

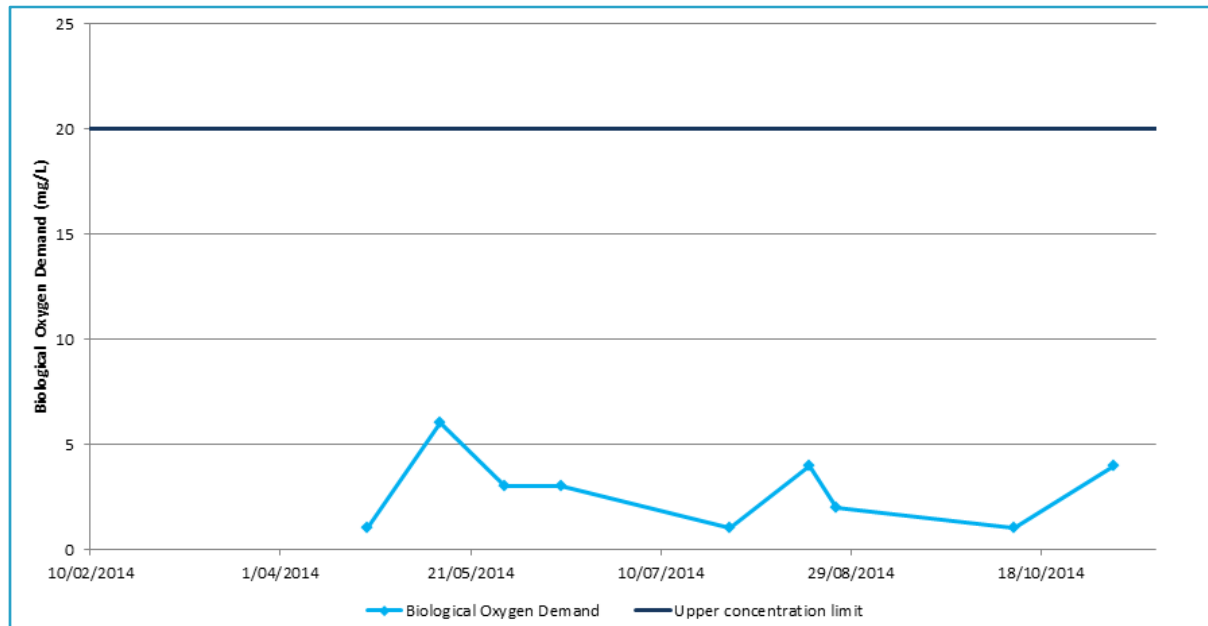
Figure 8 BOD levels for discharge water at the Site.

The recorded BOD levels for discharged water at the site were compliant with the Site's EPL, remaining significantly below the prescribed maximum concentration limit of 20 mg/L as shown in **Figure 8**. BOD levels were recorded at an average 3.7 mg/L, with a maximum recording of 6 mg/L which was still 14mg/L below the EPL concentration limit for the Site. While the sample size remains small, available data suggests BOD levels at the site remain stable within the range of 1 – 6 mg/L.

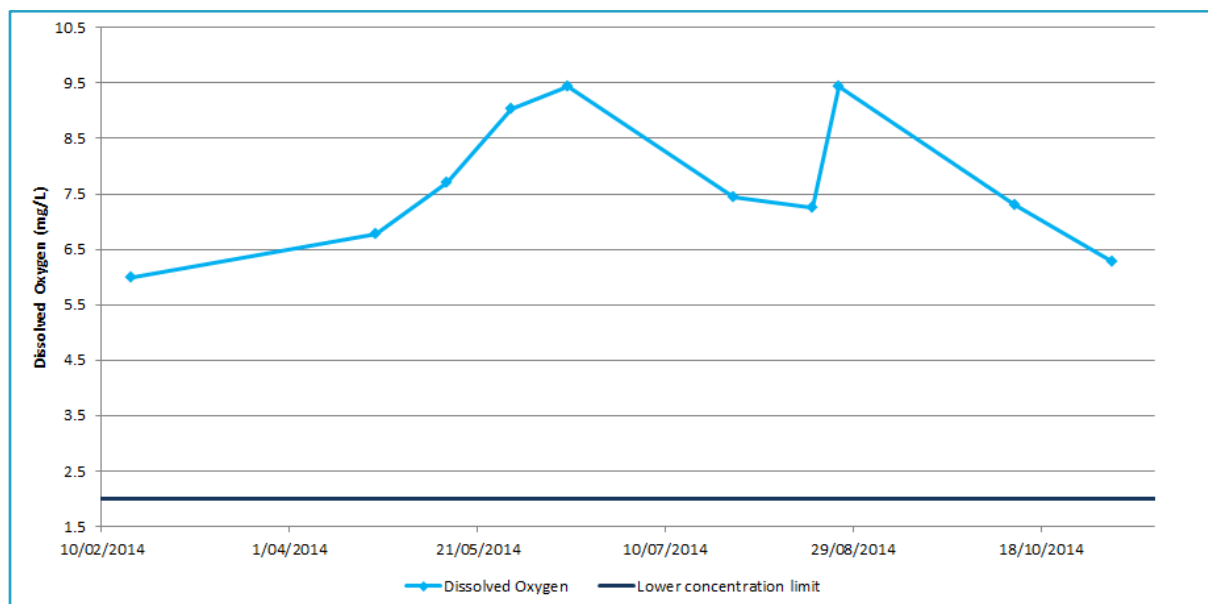
Figure 9 Dissolved Oxygen levels for discharged water at the Site

The recorded dissolved oxygen levels for discharged water at the site were compliant with the Site's EPL, remaining above the prescribed minimum concentration limit of 2 mg/L as shown in **Figure 9**. Dissolved Oxygen was recorded at an average of 7.7 mg/L with a minimum recording of 6 mg/L, which was still well above the minimum EPL concentration limit for the site of 2 mg/L. While the sample size remains small, available data suggests that dissolved oxygen levels at the site remain stable within a range of 6 to 9.5 mg/L.

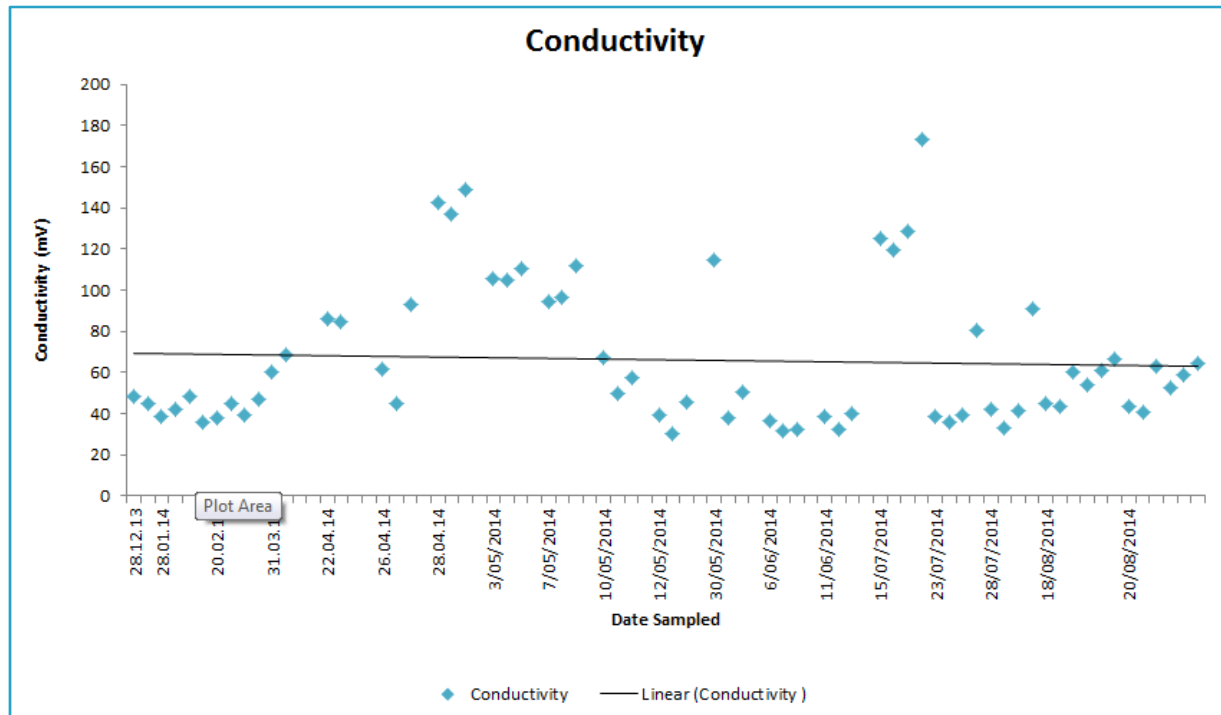
Figure 15 Conductivity Levels for Bund Water at the Site.

Conductivity levels at the site ranged from 30 to 173 $\mu\text{S}/\text{cm}$ and were recorded at an average of 71 $\mu\text{S}/\text{cm}$. As shown in **Figure 15** conductivity levels in the bund water at the site were quite varied over the reporting period but no real trend could be identified in the data available.

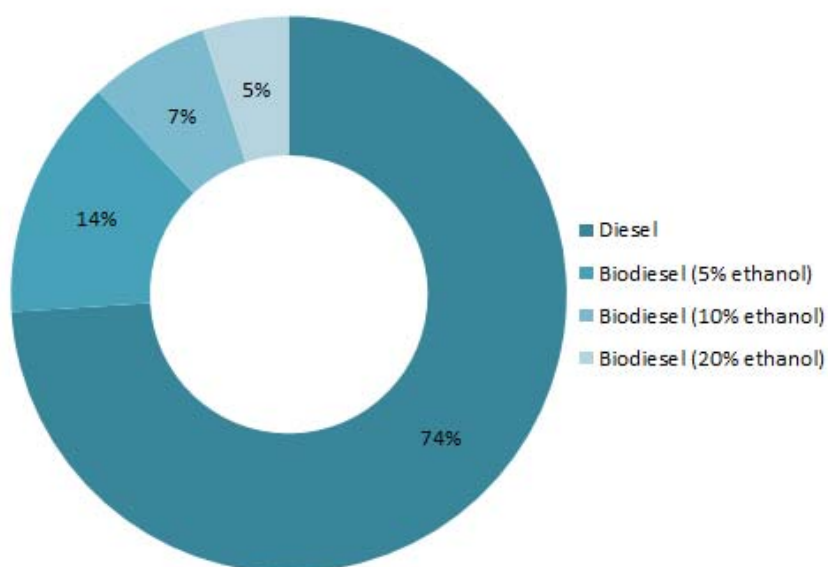
Figure 16 Overall Production Export Percentage

A total of 761ML of fuel was transported from the site via trucks who serviced Viva Energy Australia and Glencore over the reporting period. A breakdown of fuel transport is provided in **Table 16** and **Figure 16**. In this reporting period, diesel accounted for 74% of all fuel transported from the site which equates to 563ML. As the data series for fuel throughput increases over time, changes to demand in different fuel types will be able to be analysed and compared with future reporting periods.

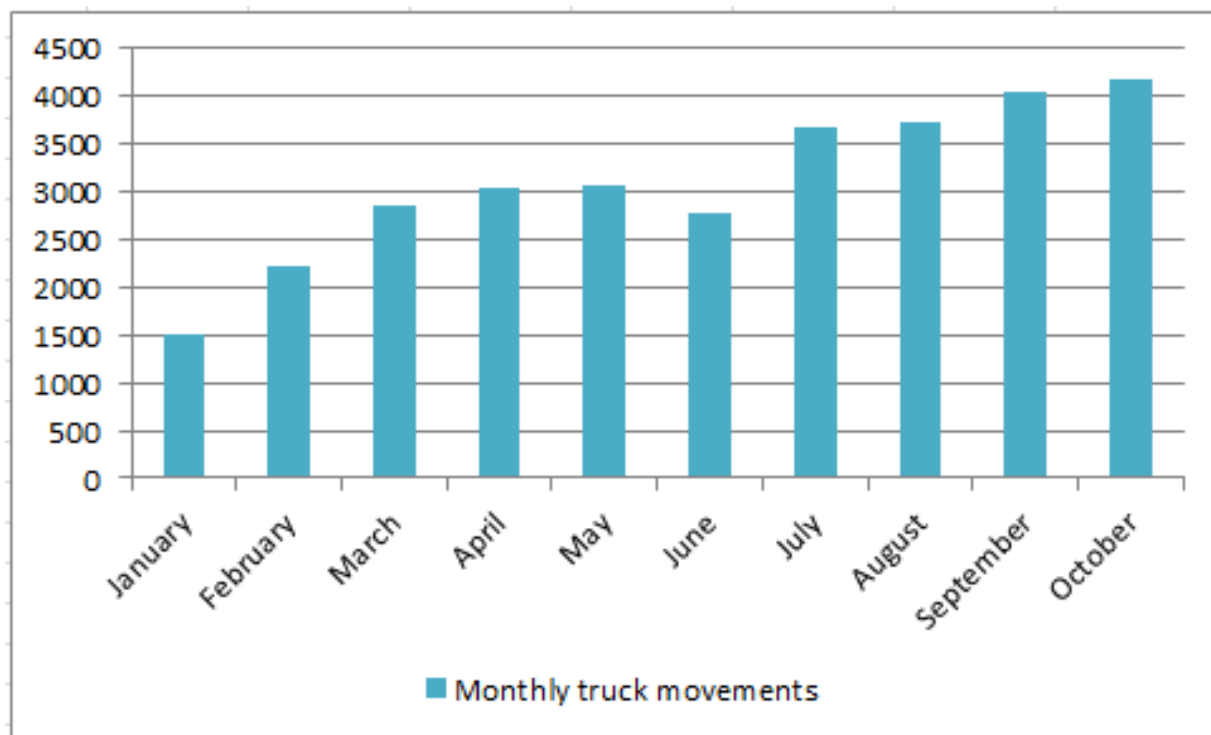
Figure 17 Monthly Truck Movements

A summary of the monthly truck movements that occurred to and from the site are shown in **Figure 17**. Over the reporting period there were a total of 31,088 truck movements at an average of approximately 3100 each month.

As the Site only became operational in December 2013 the general trend of increasing truck movements over the reporting period reflects increasing fuel inputs at the site (starting from no input prior to December 2013) and subsequent increases to the amount of fuel that was approved to be dispatched pursuant to the Project Approval Modifications 1 and 3.
